# CRS-8500

## Feed Gap Adjustment

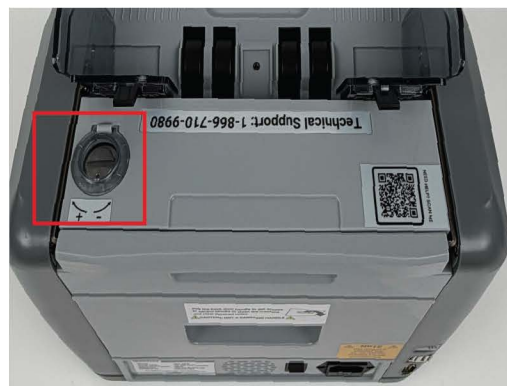
1. Make sure the unit is powered off before proceeding.
2. Find the feed gap adjustment knob located on the top panel.
