# CRS-9500

## Feed Gap Adjustment

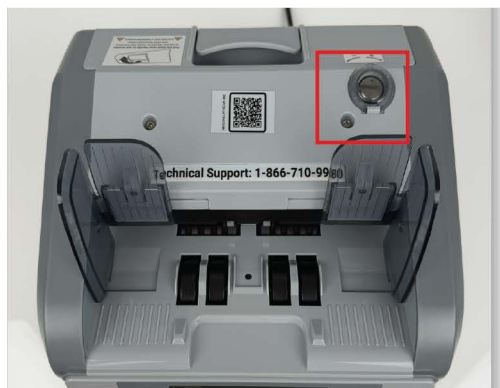
1. Make sure the unit is powered off before proceeding.
2. Find the feed gap adjustment knob located on the top panel.

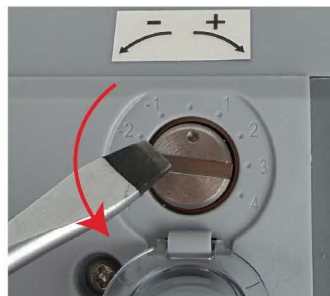
3(a). If more than one bill is being pulled through the bill feeder at a time (causing Double and/ or Chain errors), tighten the feed gap by turning the knob counterclockwise (towards the "-" mark).

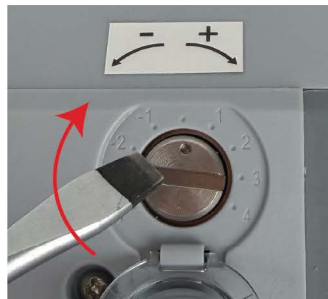
3(b). In case of Chain errors or bill jamming, loosen the feed gap by turning the knob clockwise (towards the "+" mark).
