# CRS-6200

## Feed Gap Adjustment

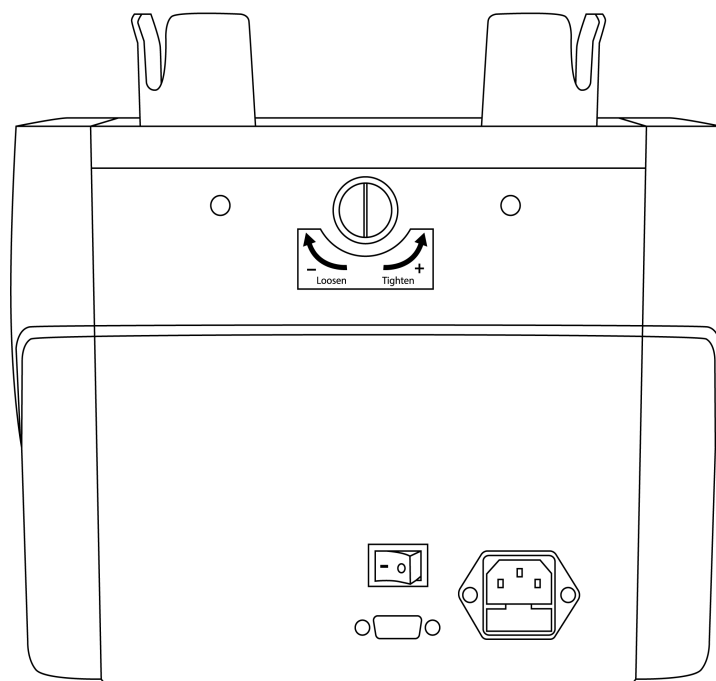
1. Make sure the unit is powered off before proceeding.
2. Find the feed gap adjustment knob (as shown on the diagram to the right)
3. Adjust for different bill thickness (narrow for fresh, new bills; wide for very old bills)

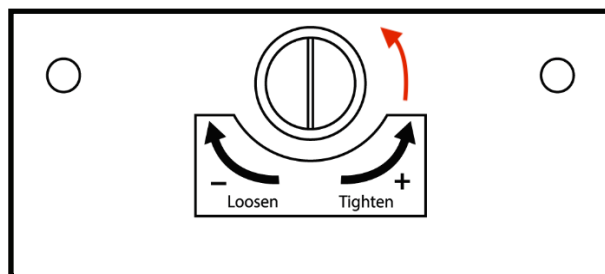
- 3a. If more than one bill is being pulled into the feed mechanism (Double/Chain errors), turn the knob counterclockwise (decrease gap adjust 1 turn, then re-test the machine to see if the problem is corrected. Repeat if necessary.

NOTE: If the feed gap is adjusted too narrow, chain error, bill jams and tears can occur.

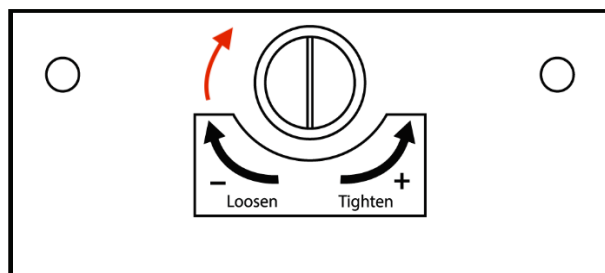
- 3b. If Chain error or bill jamming is seen on the input, turn the knob clockwise (increase gap). Adjust 1 turn, then re-test the machine. Repeat as necessary.

NOTE: If the feed gap is adjusted too wide, double and half errors can occur.
