# CRS-7500

## Feed Gap Procedure

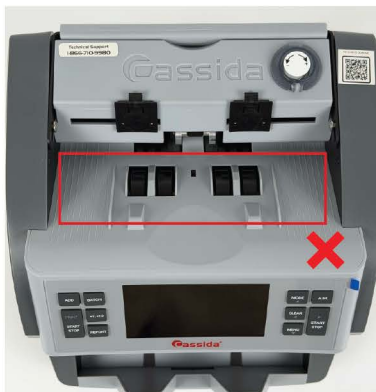
Incorrect Position

1. Ensure the machine is turned off.
2. Position the rollers so that only two teeth in from are visible. This can be done by manually turning the rollers until only two teeth are showing and the smooth section of the rollers mainly is visible (see images below).

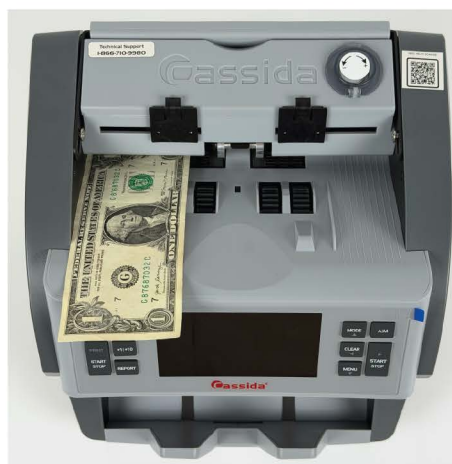
3. Place one bill that is crisp and rigid enough to prevent bending during the adjustment procedure. Place the bill lengthwise either to the right or left side of the hopper (see image below).

Guide the bill between the inner rollers. During this step, moderate resistance should be felt as the bill is moved back and forth between the rollers. In other words, the gap between these rollers should be wide enough to pass one bill per count, but narrow enough to feel slight tension or friction when pulling the bill out.

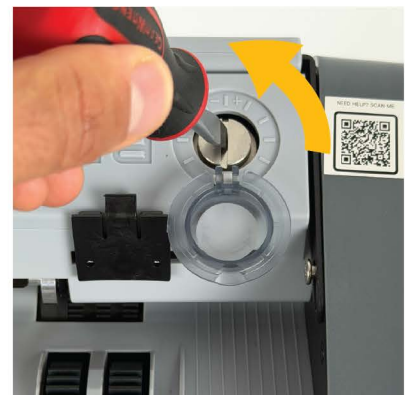
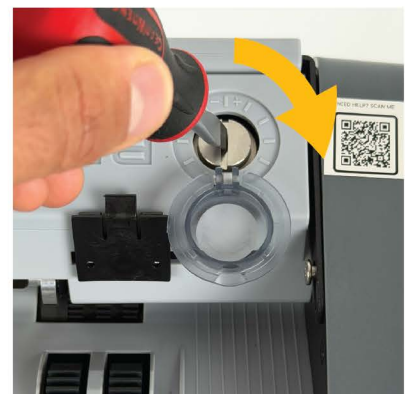
To adjust the feed gap, use the instructions below to turn the adjustment screw on the top of the unit:

- a) Adjust the knob, a slight turn at a time, and then retest.
- b) If the bill feels too loose, tighten the feed gap by turning the adjustment screw counterclockwise.
- c) If the resistance against the bill feels too strong, loosen the gap by turning the screw clockwise.

The Cassida CRS-7500 feed gap adjustment can be sensitive during adjustments. Do not overturn each adjustment or you may overshoot the optimum gap. We recommend testing with a stack of bills after each adjustment turn.
